Test Report No. 7191338137-MEC24/03-KDA
dated 17 Feb 2025

Laboratory measurement of airborne sound insulation loss of single glazed partition submitted by SAAS Solutions Pte Ltd on 13 Nov 2024.

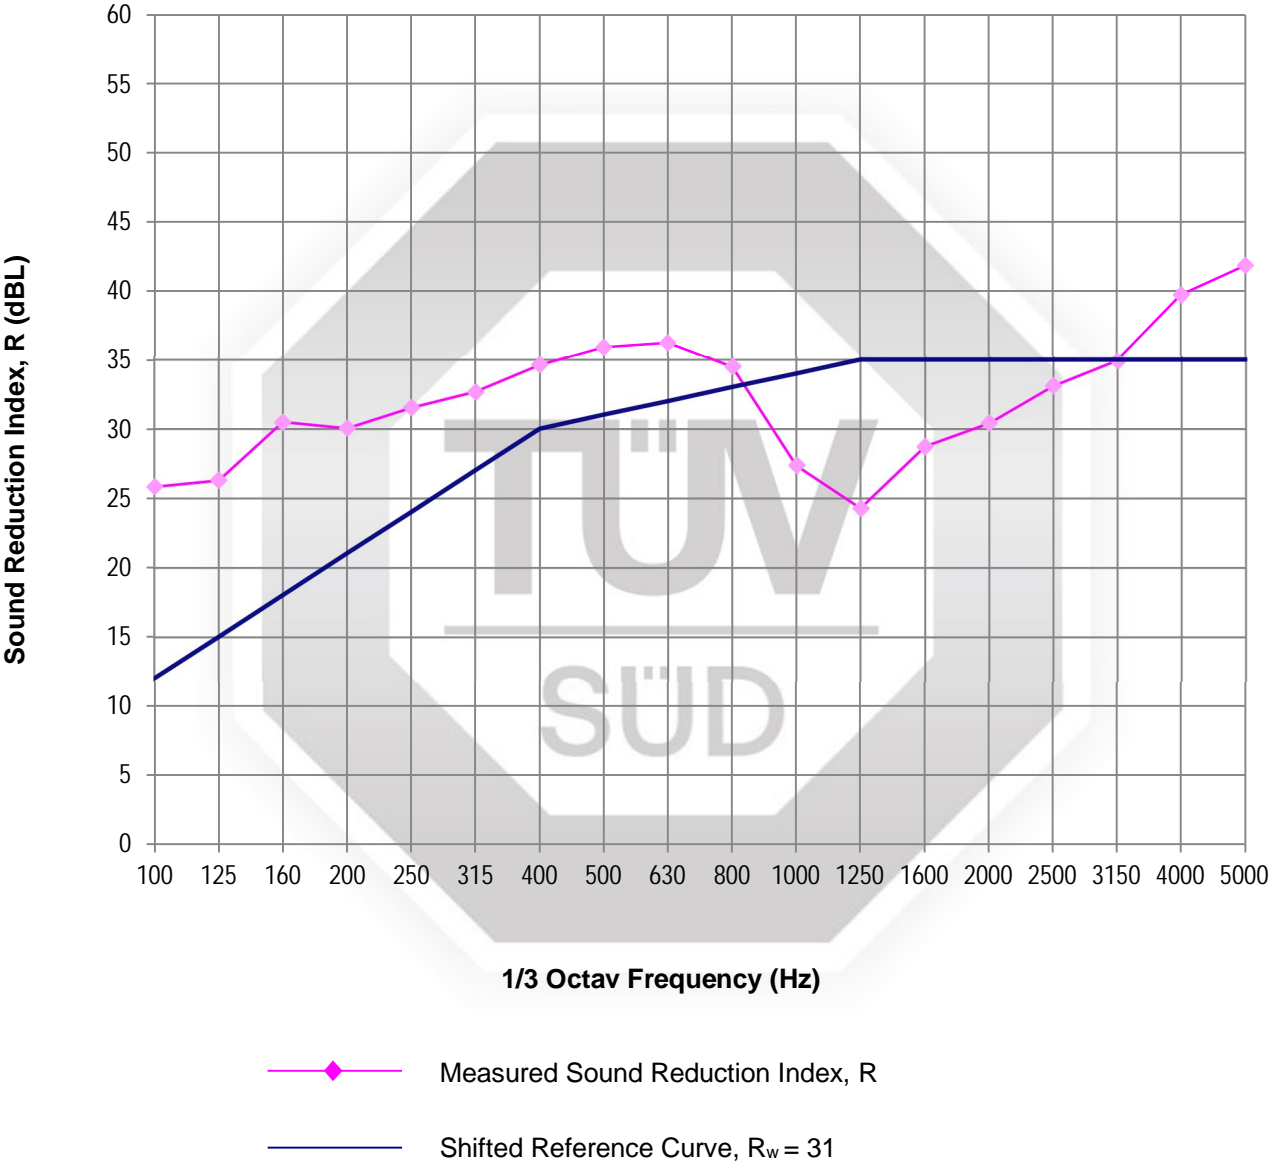
Figure 1: Sound Insulation Performance of “S-68 Single Glazed” Partition System with 12mm thick tempered glass (R_w 31)

1/3 Octave Band Frequency (Hz)	Sound Reduction Index, R (dBL)	Shifted Reference Curve $R_w = 31$	Deficiency
100	25.8	12	0.0
125	26.3	15	0.0
160	30.5	18	0.0
200	30.1	21	0.0
250	31.5	24	0.0
315	32.7	27	0.0
400	34.6	30	0.0
500	35.9	31	0.0
630	36.3	32	0.0
800	34.5	33	0.0
1000	27.4	34	6.6
1250	24.3	35	10.7
1600	28.7	35	6.3
2000	30.4	35	4.6
2500	33.1	35	1.9
3150	35.0	35	0.0
4000	39.7	35	0.0
5000	41.9	35	0.0
Total deficiency (100Hz – 3150Hz)			30.1

The values in Table 1 were plotted as shown in Figure 1.

The tested "S-68 Single Glazed" partition system with 12mm thick tempered glass achieved a weighted sound reduction index, $R_w (C; C_{tr}) = 31 (-2; -2)$.

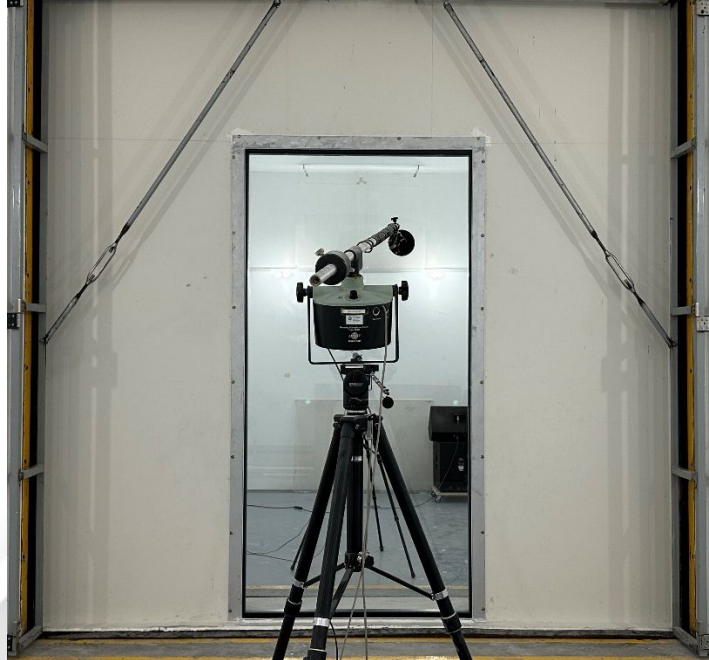
Figure 2 : "S-68 Single Glazed" partition system with 12mm thick tempered glass facing the source room

One set of single glazed partition with 12mm thick tempered glass was installed onto a filler wall of the sample carrier.

The boundary perimeters and gaps of the entire single glazed partition with tempered glass were filled up with sealant.

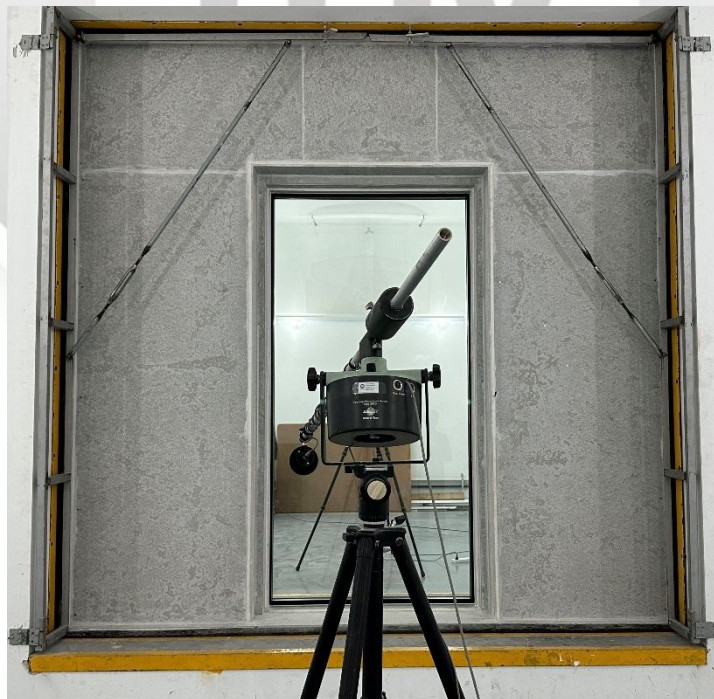
Figure 3 : "S-68 Single Glazed" partition system with 12mm thick tempered glass facing the the receiving room

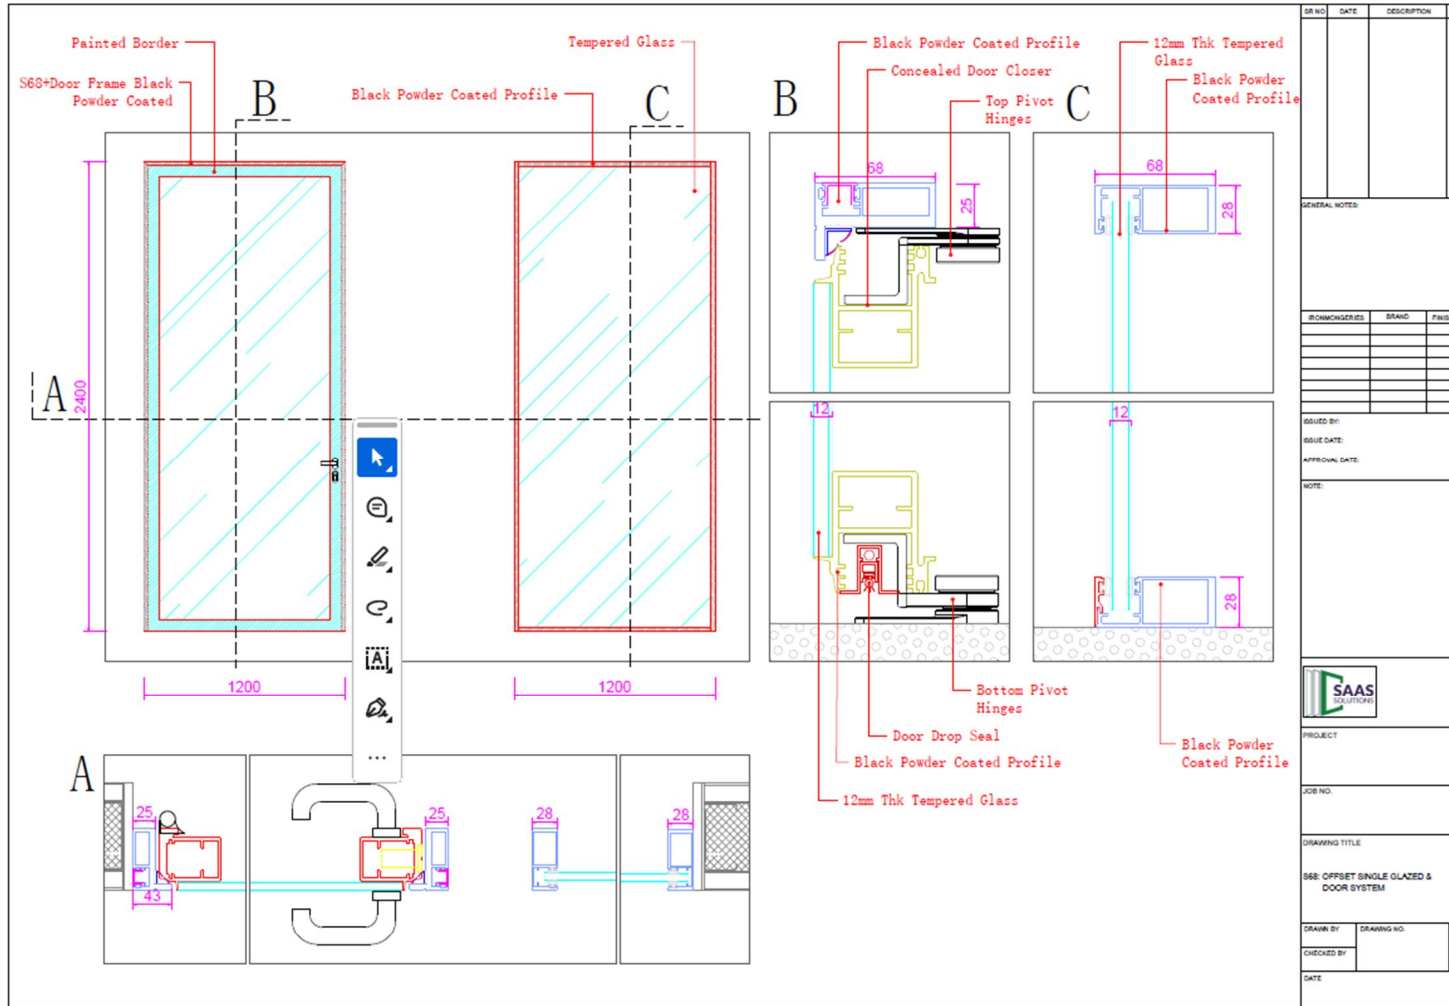
Appendix : Technical drawing of "S-68 Single Glazed" partition system with 12mm thick tempered glass

Brand Name : SAAS Solutions
Model : S-68 Single Glazed
Overall nominal size (include frame) : 1200mm (width) x 2400mm (height) x 68mm (thick)
Material composition : a) 12mm thick tempered glass;
b) Aluminium frame;

The technical drawings of the single glazed partition with tempered glass were shown in Appendix
